# Manhole Inspection Summary

Manhole # S33OO\_016MH

**Location** Address: **2325 MARYLAND AVE**

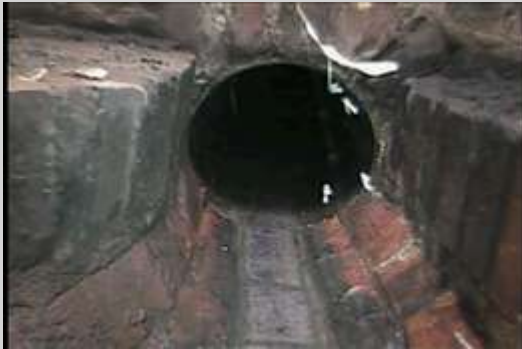
### 8 in. Circular Gravity Sewer Pipe Out @ 12 O'Clock

Rod and Bar (Angled)

Pipe Material: **Clay** ☐ Pipe Lined

Invert Depth: **8.35** (ft.) Flow Characteristics: **Slow**

Deposits: ☒ None ☐ Mud ☐ Sludge ☐ Debris ☐ Grease

Infiltration: **None** Pipe Seal Cond: **Unknown**

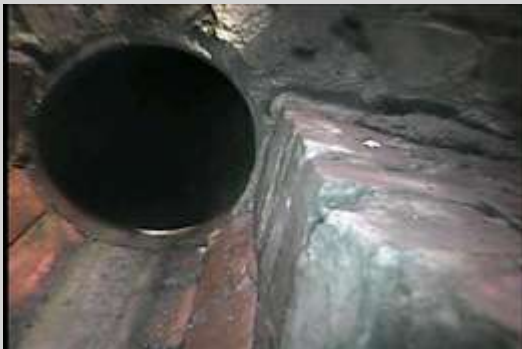
### 8 in. Circular Gravity Sewer Pipe In @ 9 O'Clock

Rod and Bar (Angled)

Pipe Material: **Clay** ☐ Pipe Lined

Infiltration: **None** Pipe Seal Cond: **Unknown**
